KOOTENAI DEVELOPMENT IMPOUNDMENT DAM

FEBRUARY 2011 ROUTINE OWNERS INSPECTION

Prepared by: Kurt Hafferman, P.E.

Inspection Date: March 04th, 2011

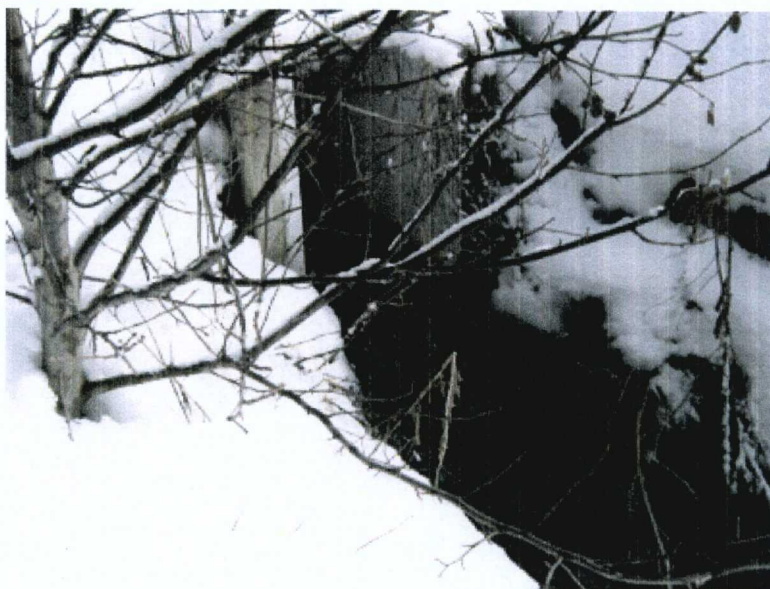
Upstream side LRC-02

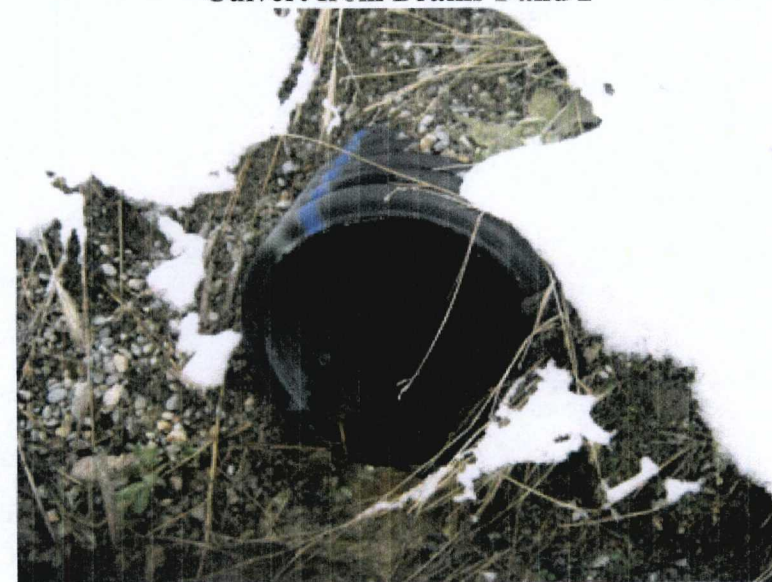
We are continuing to see flow from Drain 2. BHI has never seen water in Drain 2 during any prior winter inspection. Drain 2 does not typically run much after September and it does not typically start to run again until late may or June. We attribute this flow to the construction repairs made to the drain last year. It has been rumored that the spillway is one of the sources of water that causes Drain 1 and Drain 2 to flow. As we fully expect flows through the spillway this year we will monitor flows to determine if spillway flows affect Drain 1 and Drain 2 flows.

Culvert from Drains 1 and 2

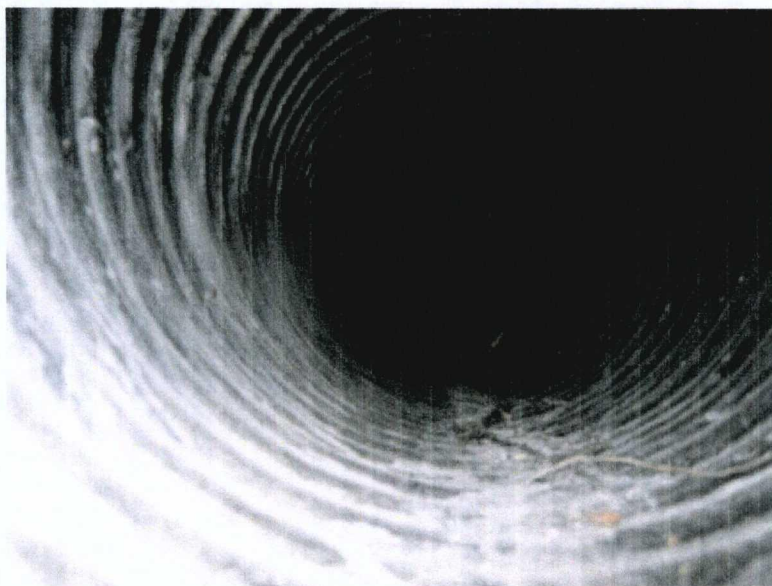
Drain 7 Seepage

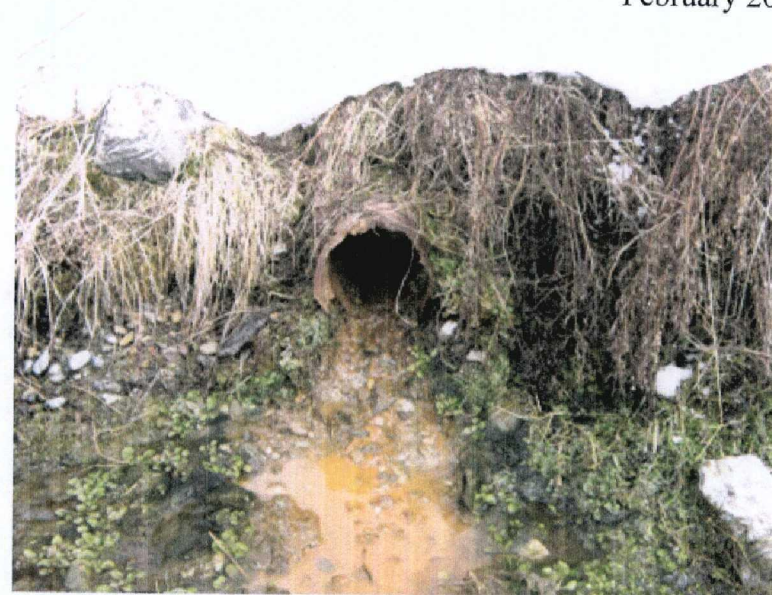
Drain 9 Flow

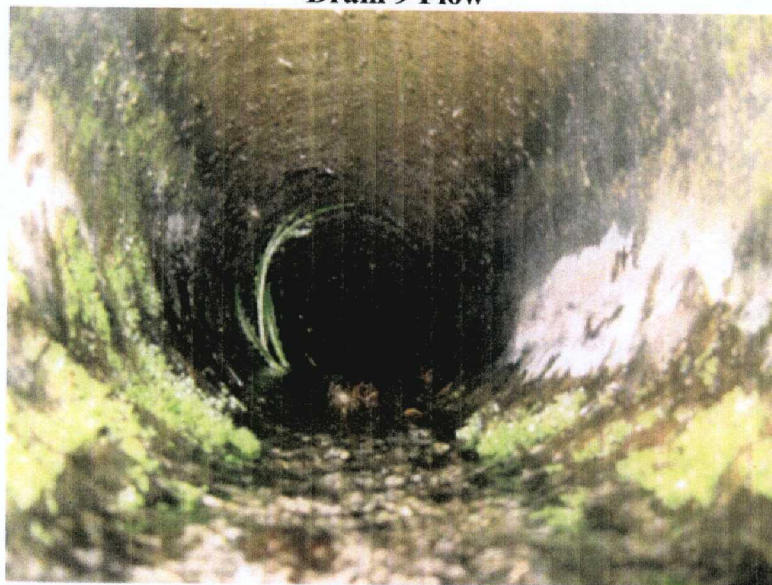
Flow from Culvert between Drains 9 and 10

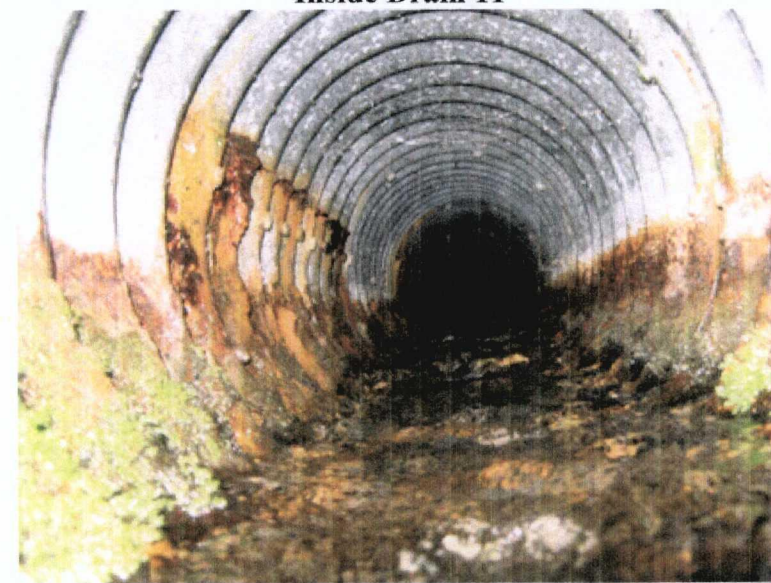
Snowmelt above Drain 11

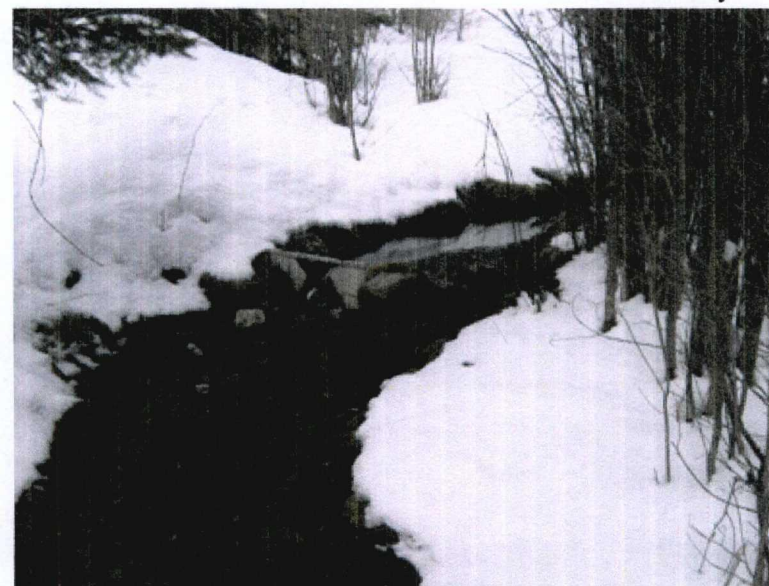
Weir 12 Flow

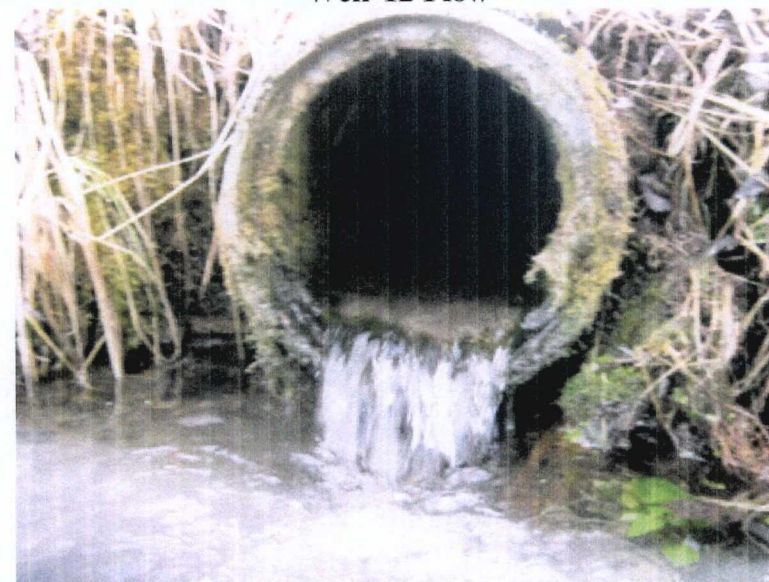
Drain 12 Flows

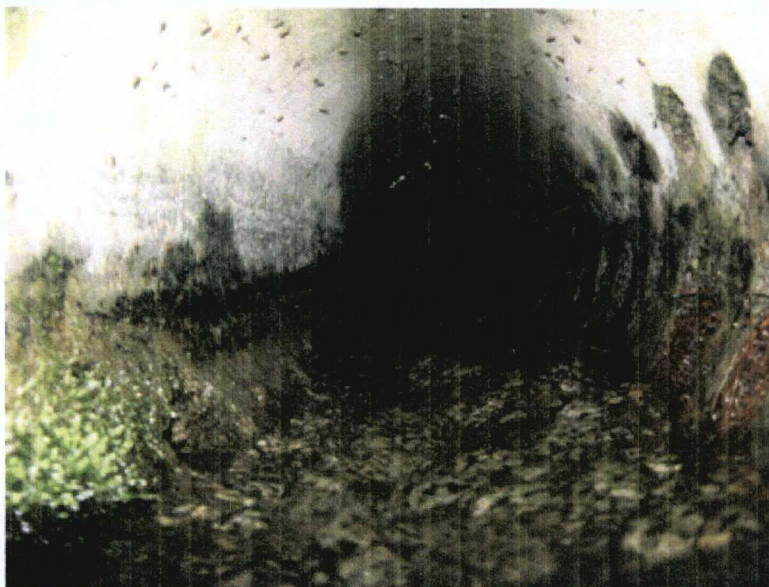
Inside Drain 12

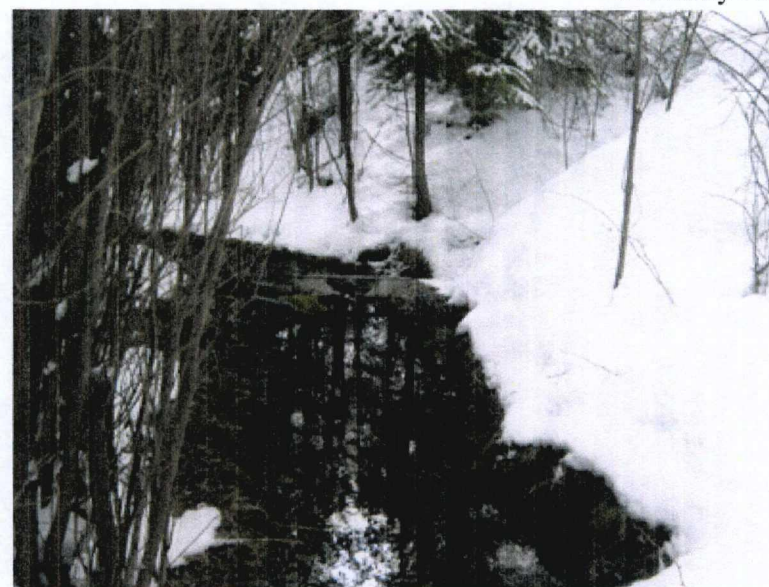
Weir 12 below Drain 12

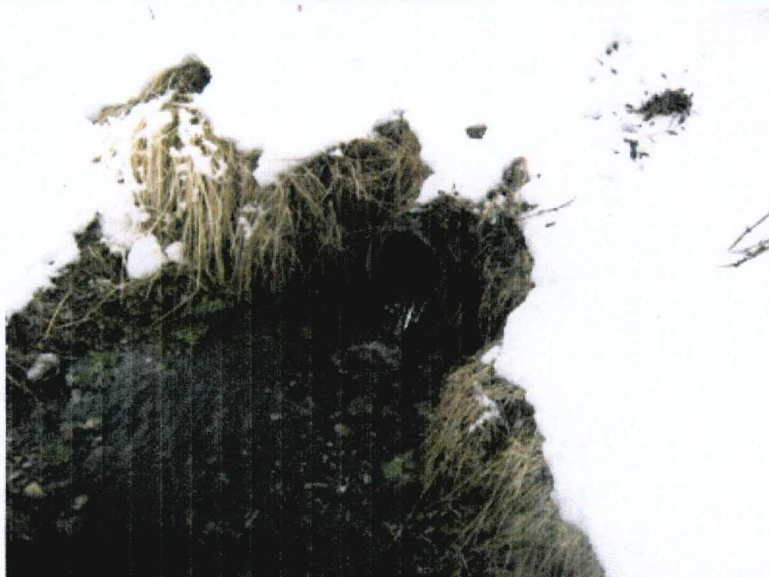
Snowmelt around Drain 12

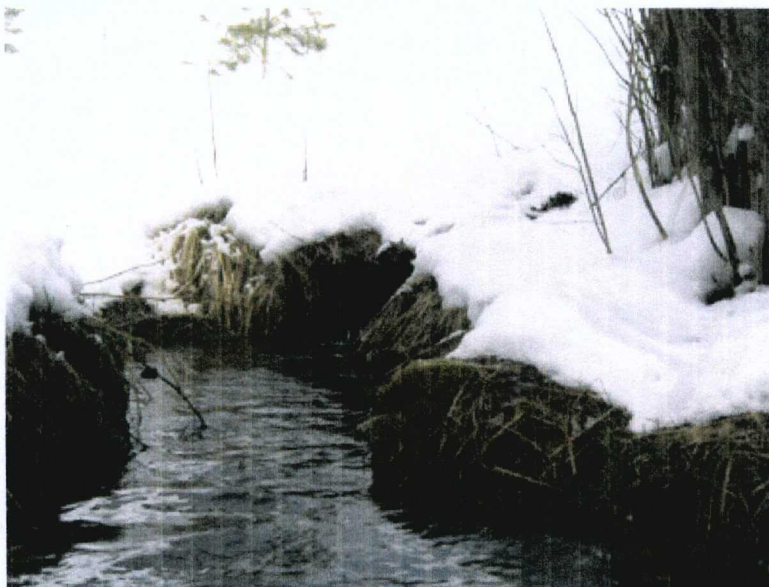
Drain 12 flows

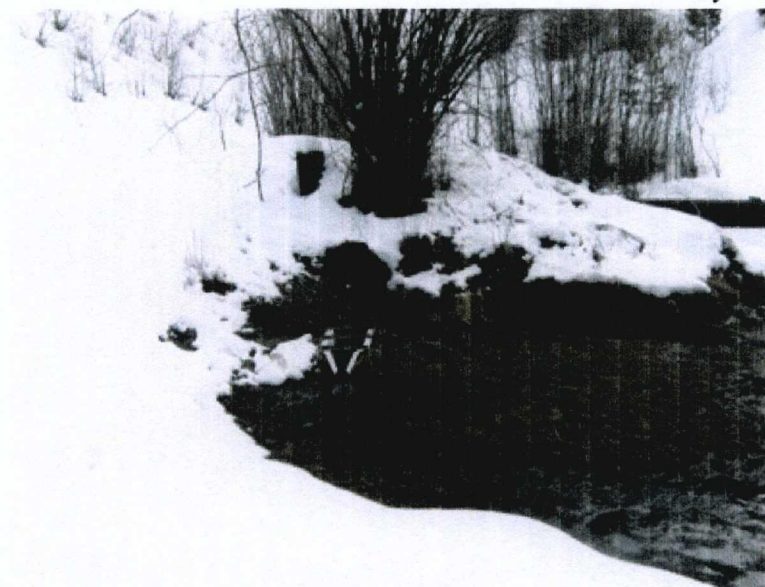
Flume 7-8 Flow

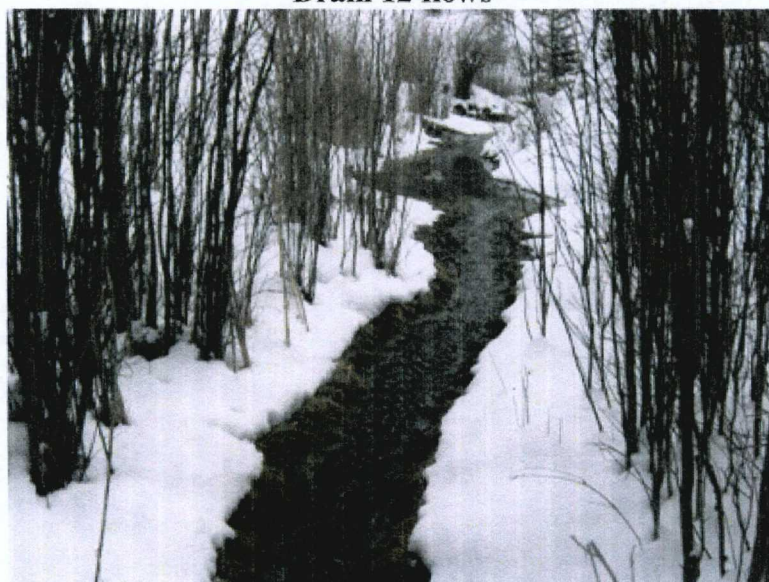
Flows below Drain 12
